AD A108849
PERFORMANCE TECHNOLOGY PROGRAM
(PTP-S II)

VOLUME X

MATERIAL CHARACTERIZATION OF POST-TEST ABLATION
MODELS

SCIENCE APPLICATIONS, INC.
MATERIAL SCIENCES OPERATION
IRVINE, CALIFORNIA 92715

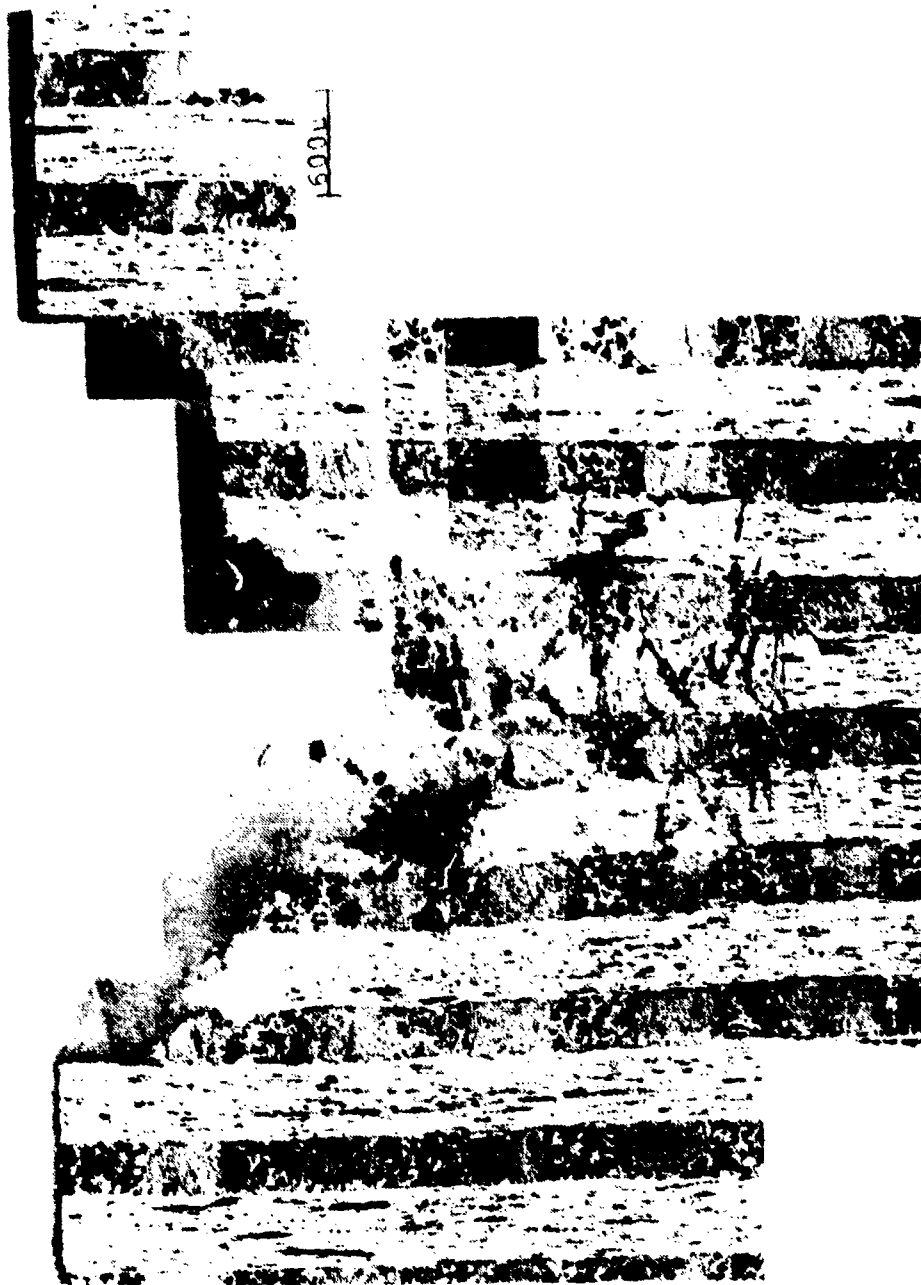
Figure 85 CROSS SECTION SHOWING EFFECT OF SINGLE PARTICLE IMPACT AT
ROOM TEMPERATURE ON AXIAL YARNS OF 223 T-50 (1000 μ glass bead,
13.2 kfps, 70°F)

Cross-sections of the specimens which were impacted with 1000 micron glass beads at room temperature are shown in Figures 85 through 88. The standard 223 material shows considerable in-depth damage immediately below the impact site with extensive crushing at the bottom of the crater. The view with yarns parallel to the impact direction shows both shear failures immediately under the impact site and tensile failures in one yarn immediately to the right of the crater center as evidenced by the separations in the Z yarn. The damage appears much more extensive to the transverse yarns (Figure 86) which were immediately adjacent to the view shown in Figure 85. Yarn damage occurs well beyond the central location of the impact site and approaches the edge of the crater. In some instances there appears to be damage extending out beyond the edge of the crater. In addition there is considerable in-depth deformation of the weave geometry which, upon measuring, extends several unit cells below the readily observable damage. In order to characterize this deformation measurements were made of the space between the transverse yarns immediately below, to the right, and to the left of the impact site (two unit cell measurements to the right and left of the impact site). A plot of the unit cell spacing as a function of depth from the specimen surface is also shown in Figure 86.

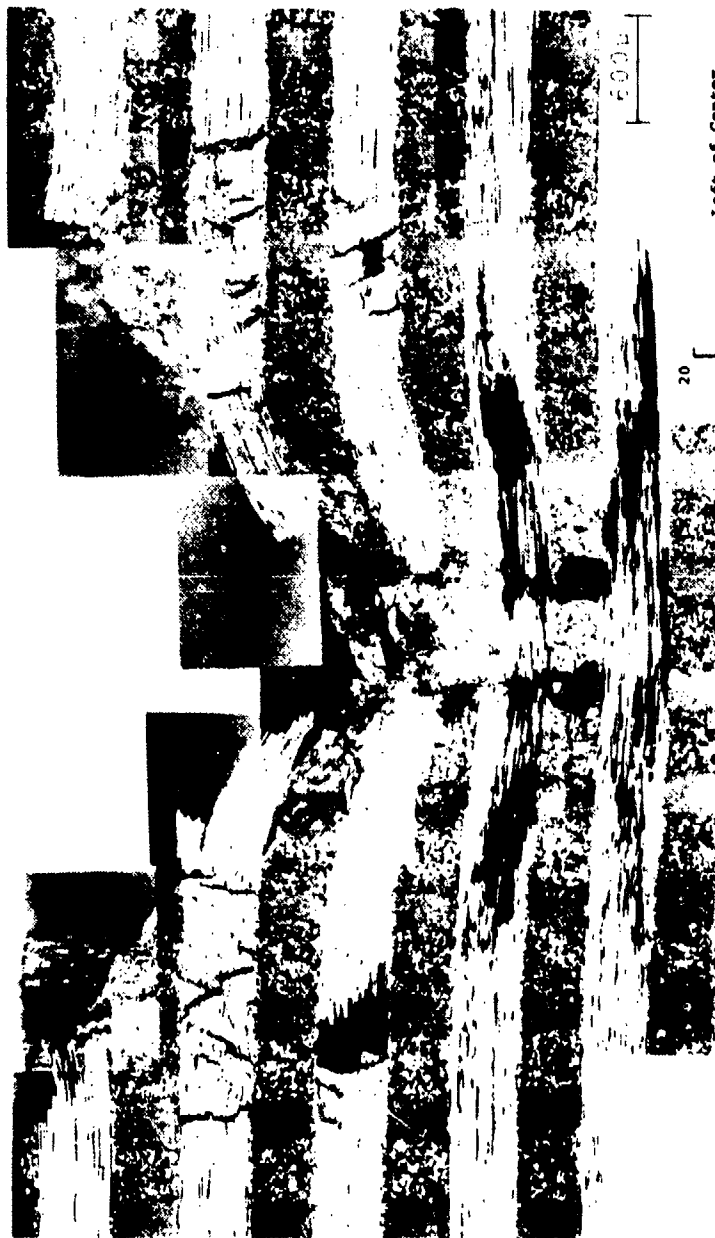
Figure 88 CROSS SECTION SHOWING EFFECT OF SINGLE PARTICLE
IMPACT AT ROOM TEMPERATURE ON TRANSVERSE YARNS
OF 223 PAN (1000 μ glass bead, 18.4 kfps, 70°F)

extensive than for Standard 223 T-50, it should be noted that the velocity of the impacting particle was much higher (18.4 versus 13.2 kfps). As was observed earlier the damage extends further toward the edge of the crater in the transverse section (Figure 88) than in the section with yarns parallel to the impact direction (Figure 87). Similarly a large amount of in-depth weave deformation was measured on this specimen as is shown by the plot included in Figure 88.

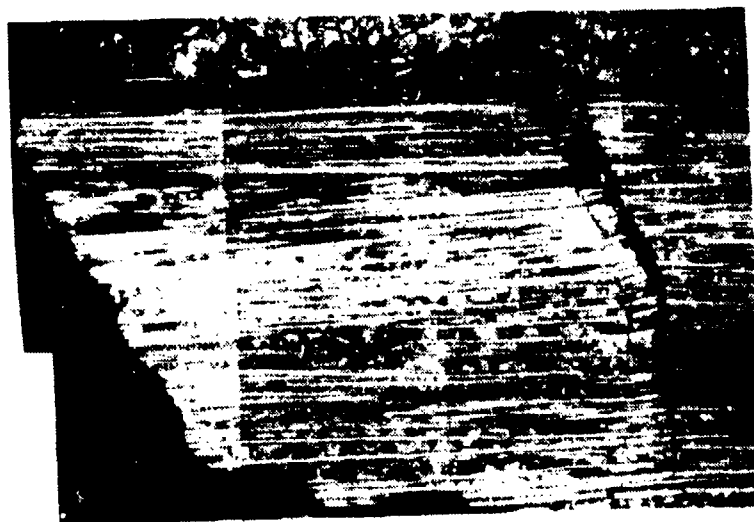
TEST NUMBER 30R-M11C
MATERIAL 1-1-1-3
VELOCITY 4202.25 kfps
ANGLE OF IMPACT 60°
PARTICLE 1.37mm Rain Drop

Figure 97 CROSS SECTION OF HOLLOMAN SLED TESTED 1-1-1-3 SHOWING
ISOLATED IN-DEPTH DAMAGE

Typical cross-sections of the specimens evaluated are shown in Figures 94 through 99. As can be seen in these photomicrographs, the primary impact damage present is small cracks observable only at high magnification in the axial yarns. However, in some isolated cases more severe cracking was also observed (Figure 97) but to a much lesser extent than that observed in single particle impact tests.

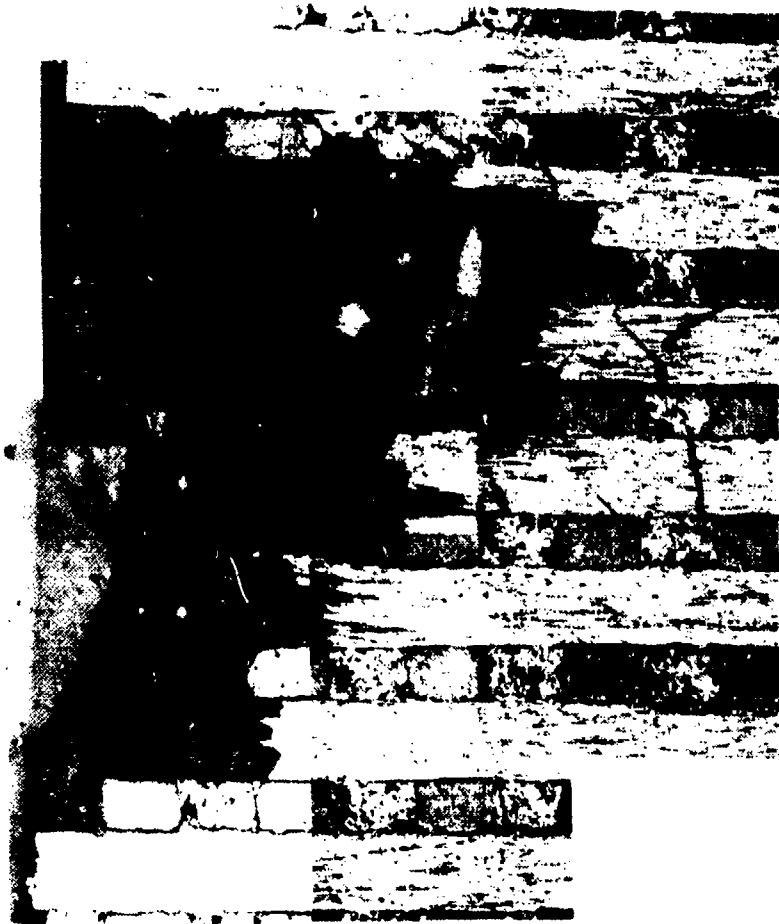
SINGLE IMPACT
Large Amount of Shear
and Buckling of Z Yarns

TWO IMPACTS IN SAME SITE
Tensile Fractures Only
in Damage Zone

Figure 100 CROSS SECTIONS SHOWING EFFECTS OF SINGLE IMPACT AND TWO IMPACTS ON STANDARD 223 (13 kfps, 700 μ particles, Track K)

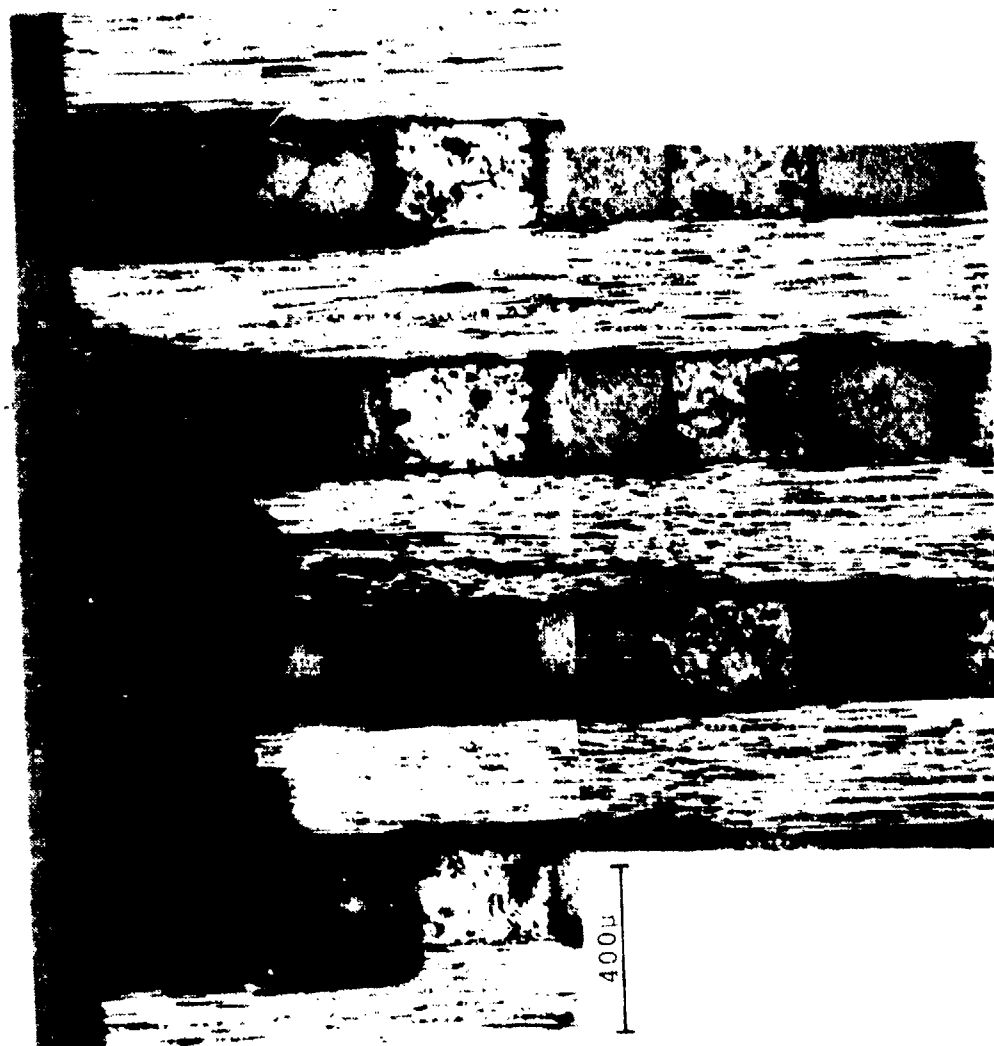
Figure 101 CROSS SECTION SHOWING THE EFFECT OF A SINGLE IMPACT ON
223 PAN (13 kfps, 700 μ particle, Track K)

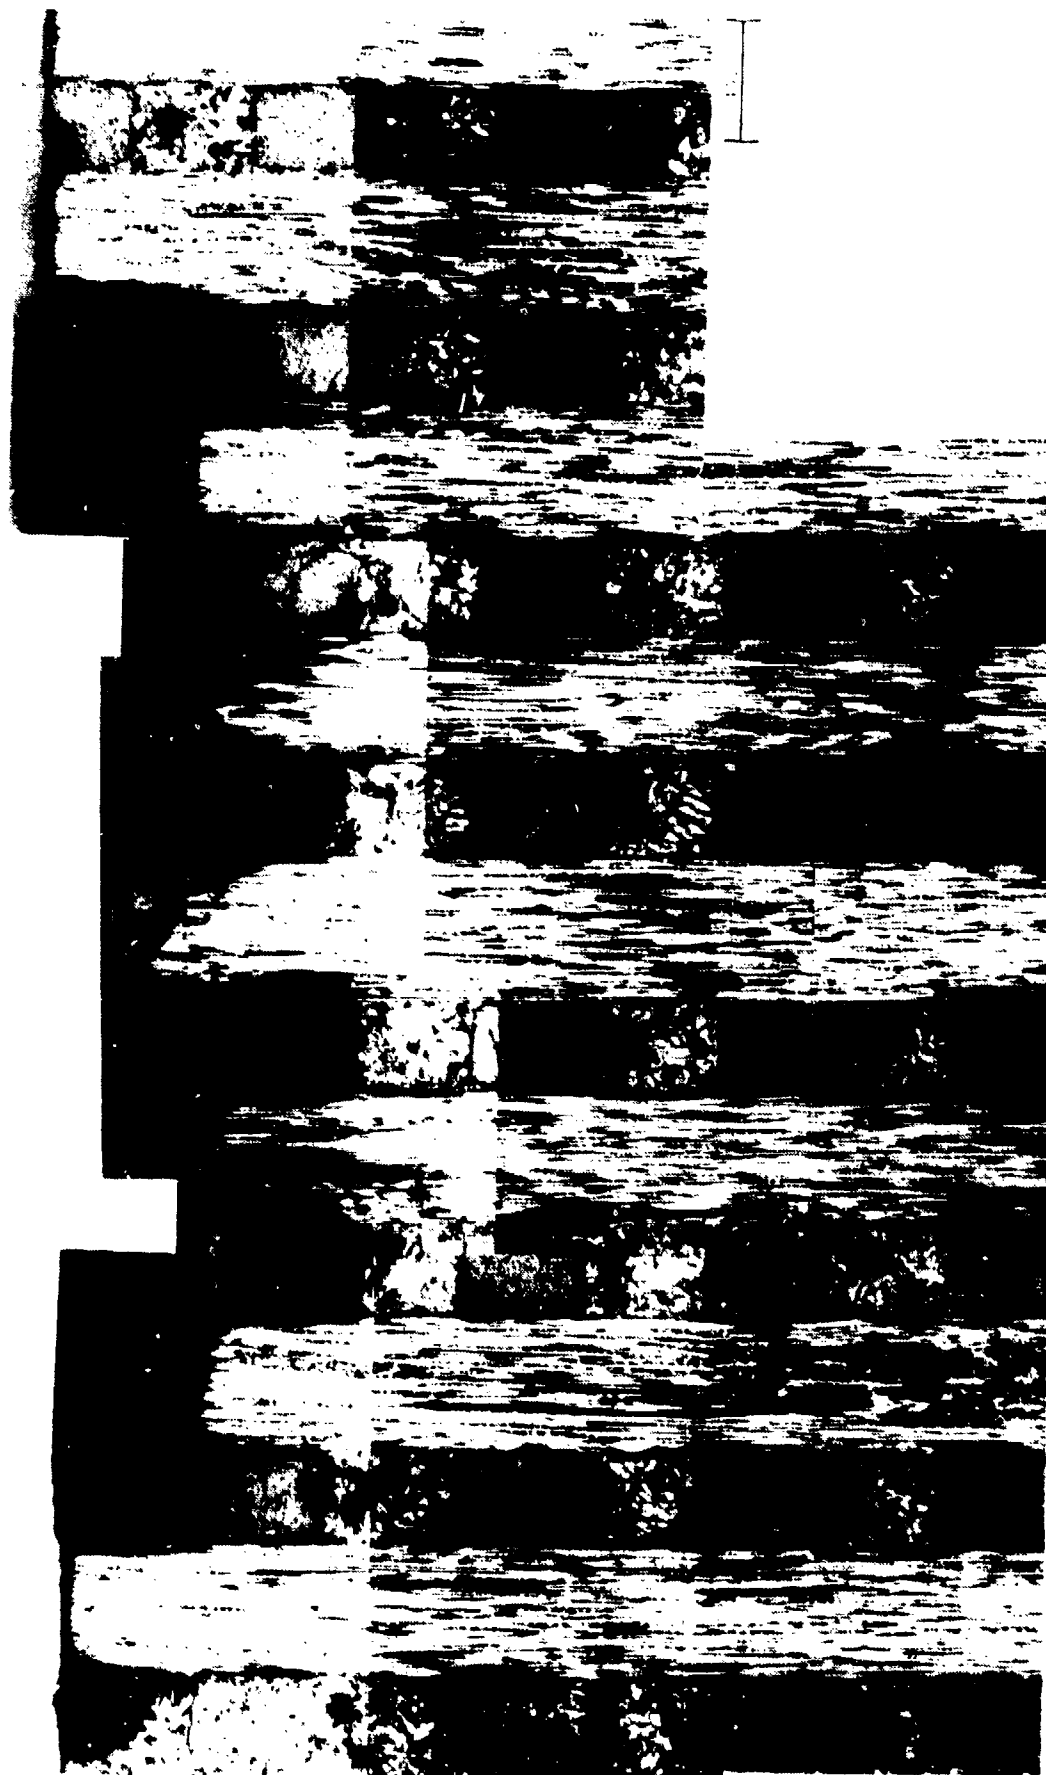
Figure 102 CROSS SECTION SHOWING THE EFFECT OF TWO IMPACTS ON 223
PAN (13 kfps, 700 μ particles Track K)
